UNITED STATES COAST GUARD

**REPORT OF INVESTIGATION INTO THE
CIRCUMSTANCES SURROUNDING THE MULTIPLE
RELATED MARINE CASUALTIES AND
GROUNDING OF THE**

MODU KULLUK

ON DECEMBER 31, 2012

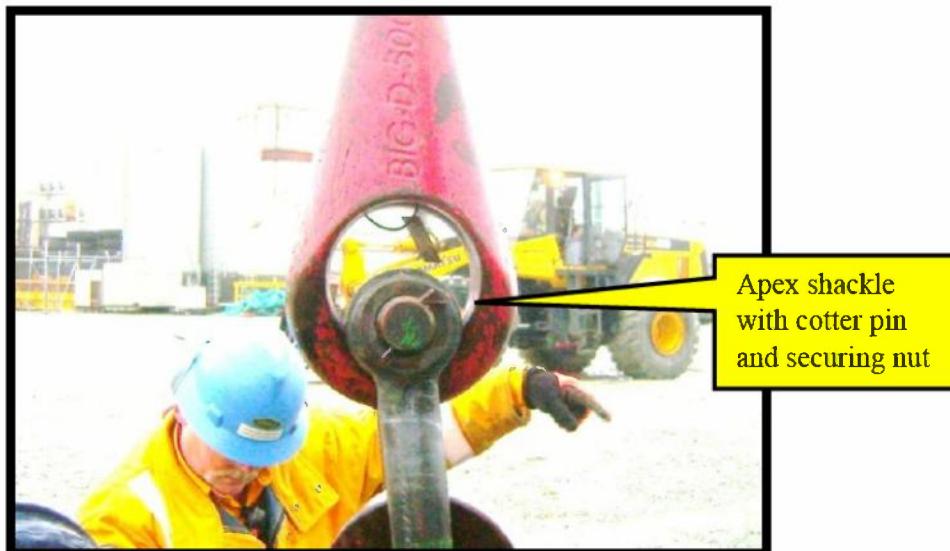
Figure 13: OSI Terminal workers hoist the tow plate and pennant wire. The photo shows the 120 ton shackle (original photo brightness adjusted) with the cotter key. The shackle (described as apex shackle) connects the tow plate to the 100' tow pennant socket. (*Photo courtesy of GL Noble Denton, Mr. [REDACTED]*)

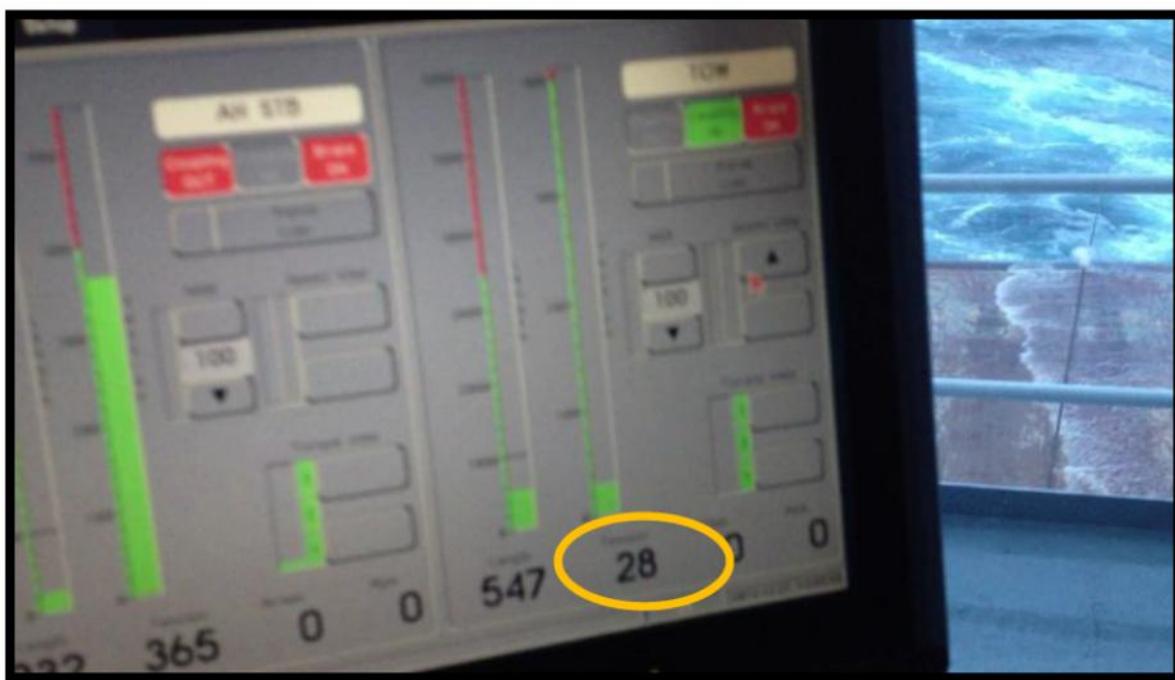
Figure 18: Screen capture from video showing tension reading of 28 tons on main tow drum. (Cell phone video screen capture provided by Mr. ████████ AIVIQ Mate)

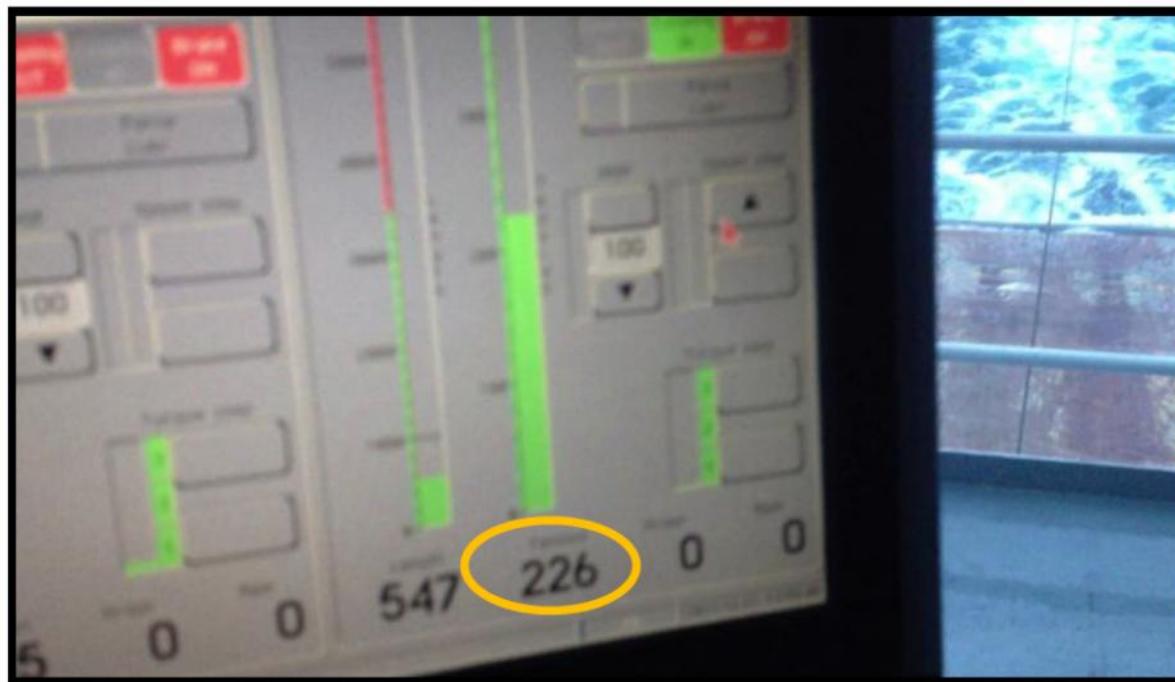
Figure 19: Screen capture from video showing tension reading of 226 tons on main tow drum. (Cell phone video screen capture provided by Mr. ████████ AIVIQ Mate)

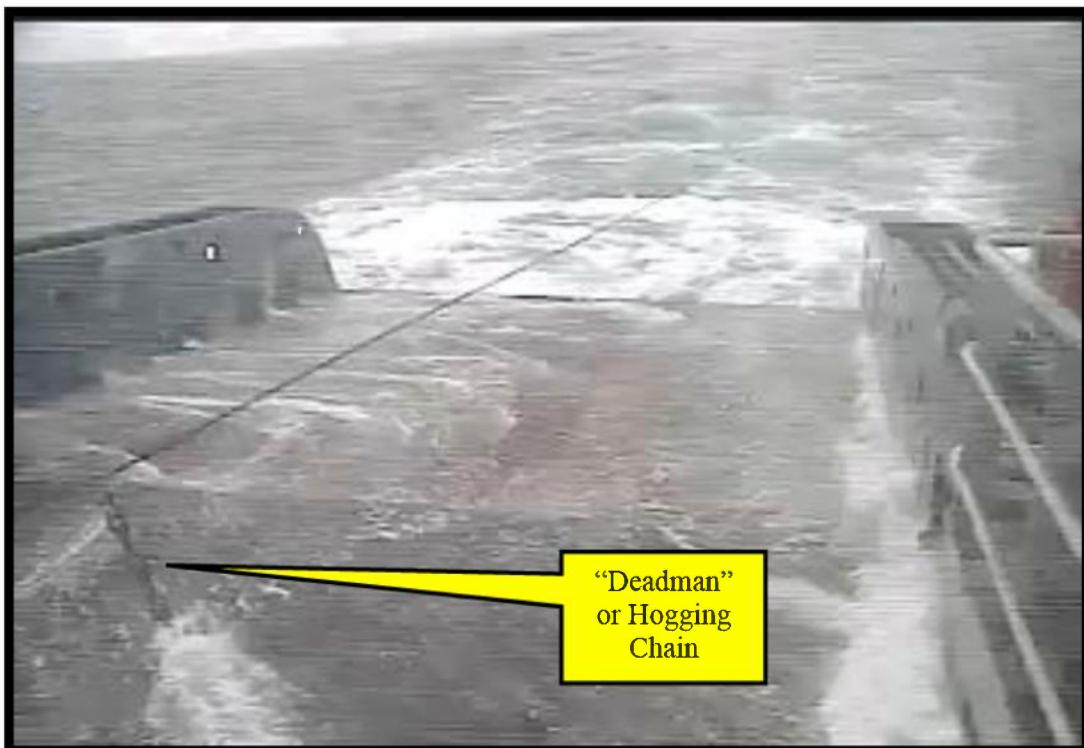
Figure 20: Screen capture of towline moments before failure of the shackle on the morning of December 27, 2012 (*From AIVIQ CCTV recording and provided by ECO*)

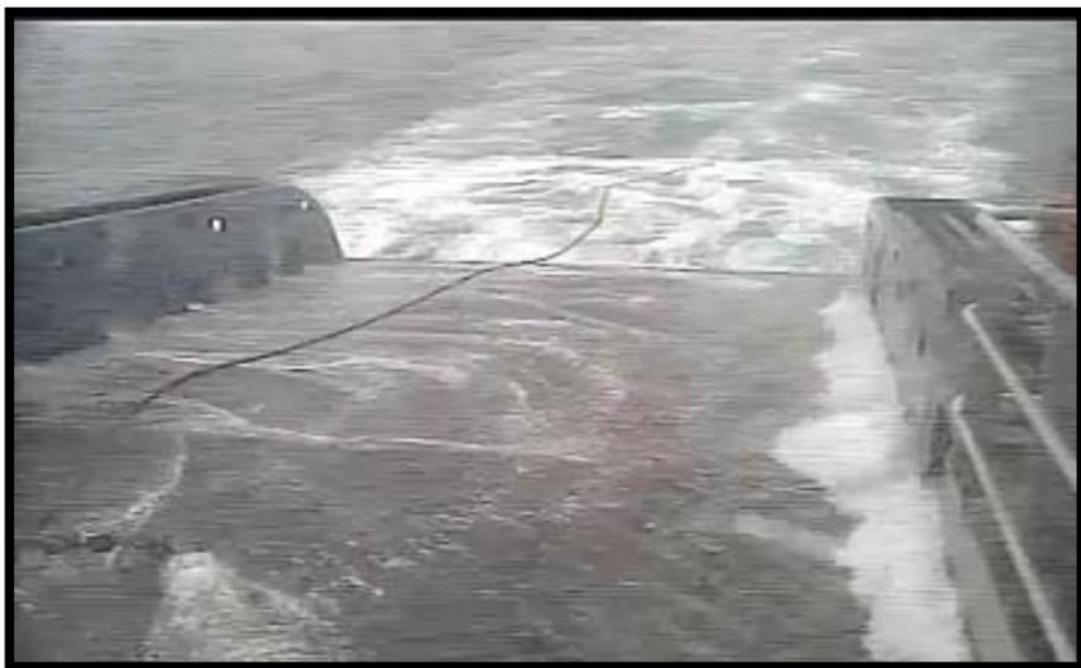
Figure 21: Screen capture of towline at moment of shackle failure on the morning of December 27, 2012 (*From AIVIQ CCTV recording and provided by ECO*)

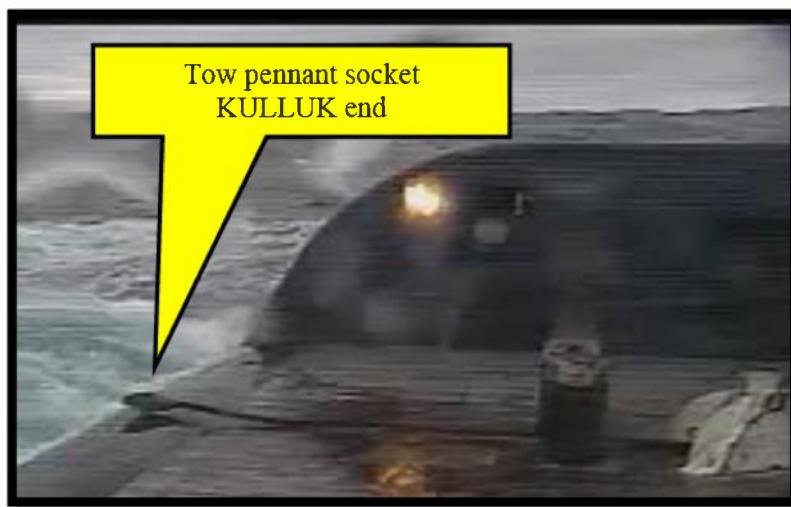
Figure 22: Screen capture showing retrieved pennant wire and socket, missing shackle later in the morning of December 27, 2012. (*From AIVIQ CCTV recording and provided by ECO*)

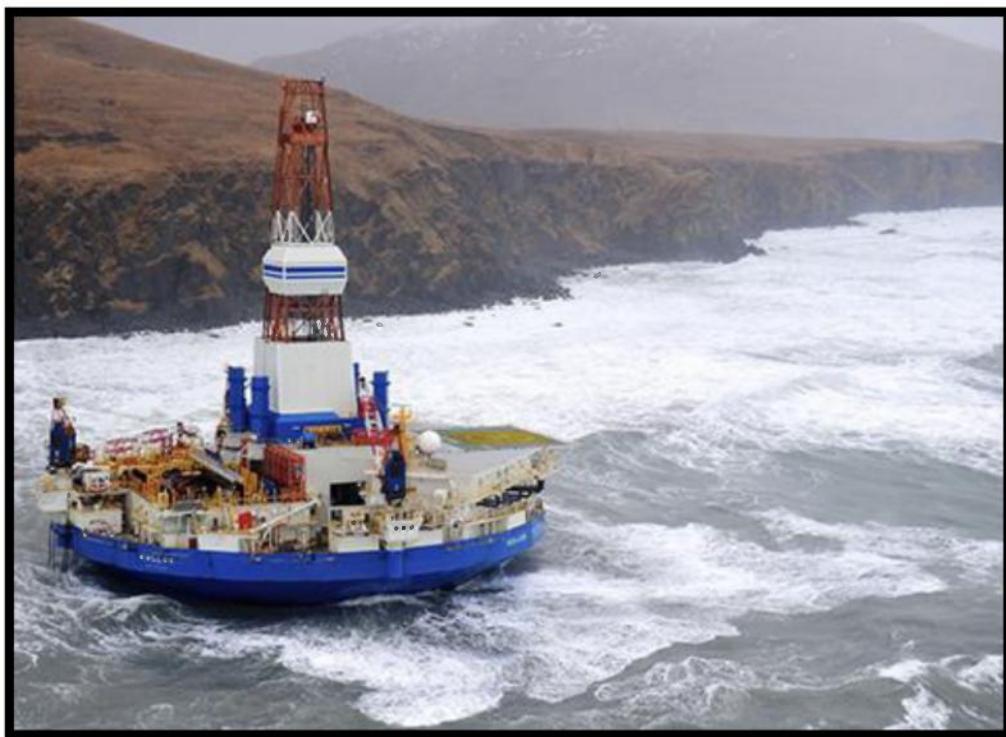
Figure 44: KULLUK grounded in Oceans Bay, Alaska. (USCG Photo)

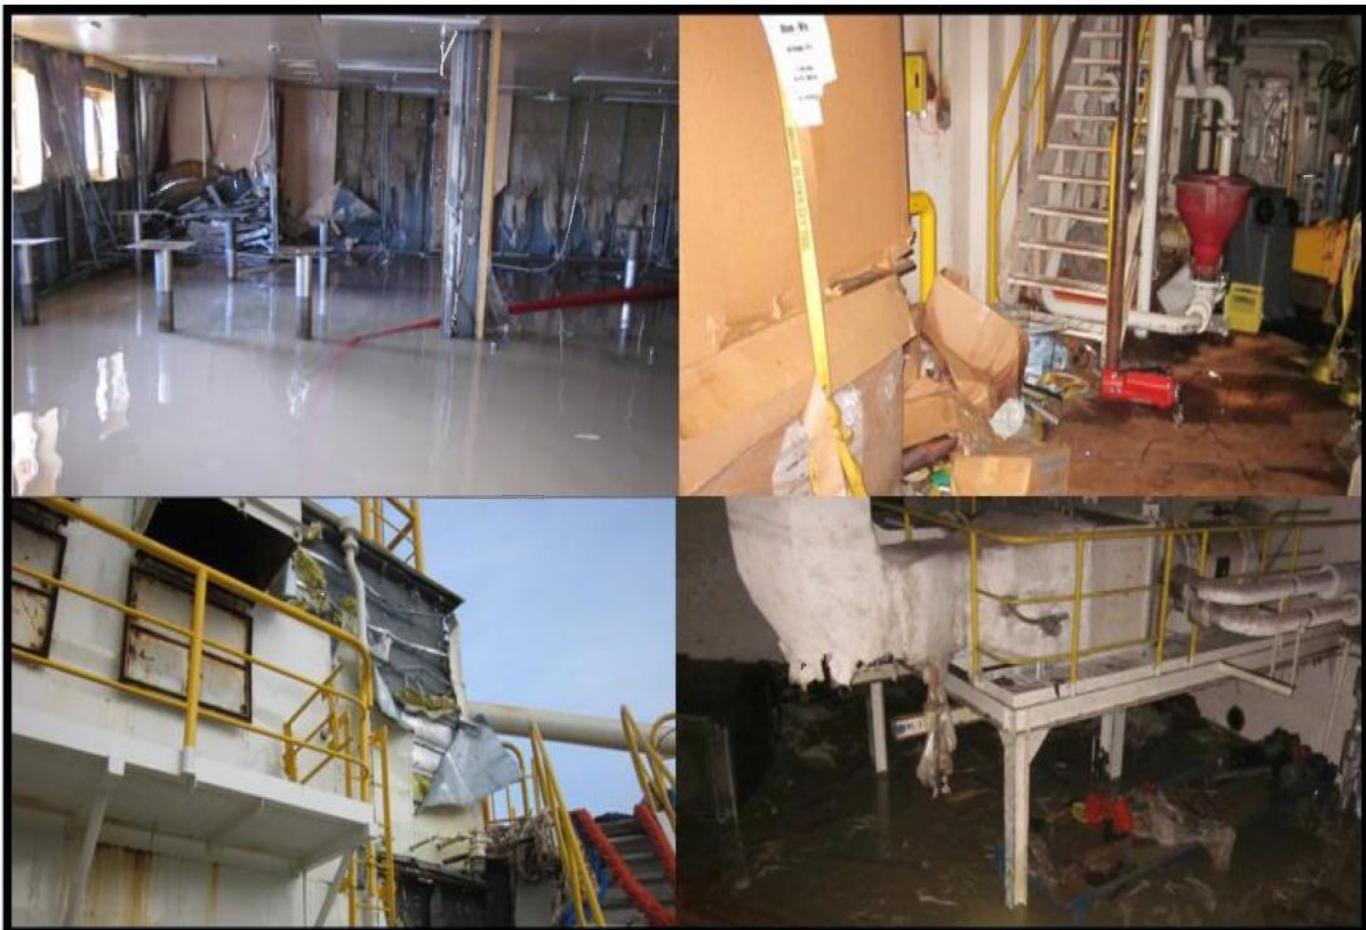
Figure 45: Composite photographs showing damage to topside areas of the KULLUK taken by USCG Inspectors after the grounding and prior to refloating. (*USCG Photos*)

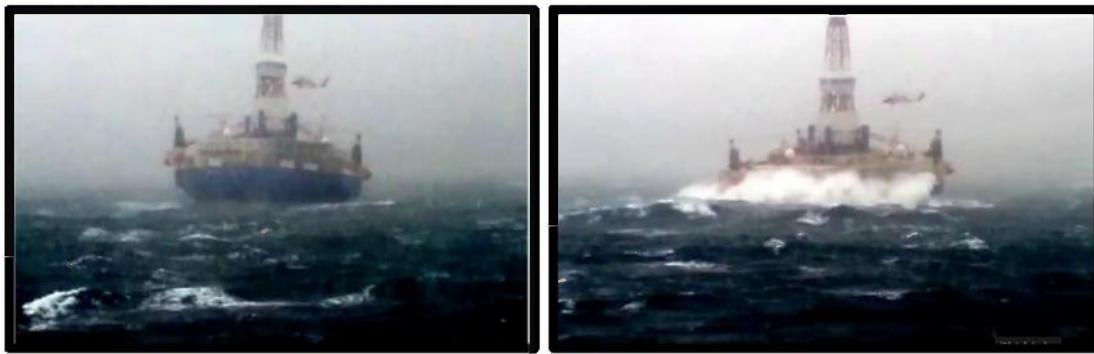
Figure 48: Screen captures showing extreme pitching resulting in the KULLUK burying hull into seaway and causing increased towing resistance. (*Taken from YouTube video taken by unknown AIVIQ crewmember during afternoon hours of 31 December with AIVIQ and ALERT towing, video titled “KULLUK rescue 2012 Gulf of Alaska”*)

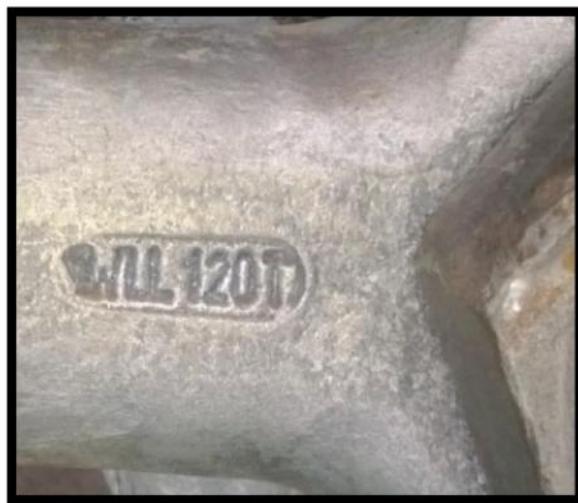
Figure 55: Photo of Working Load Limit Stamped on Bow of 120 Van Beest Green Pin® Super Shackle. (*USCG Photo*)

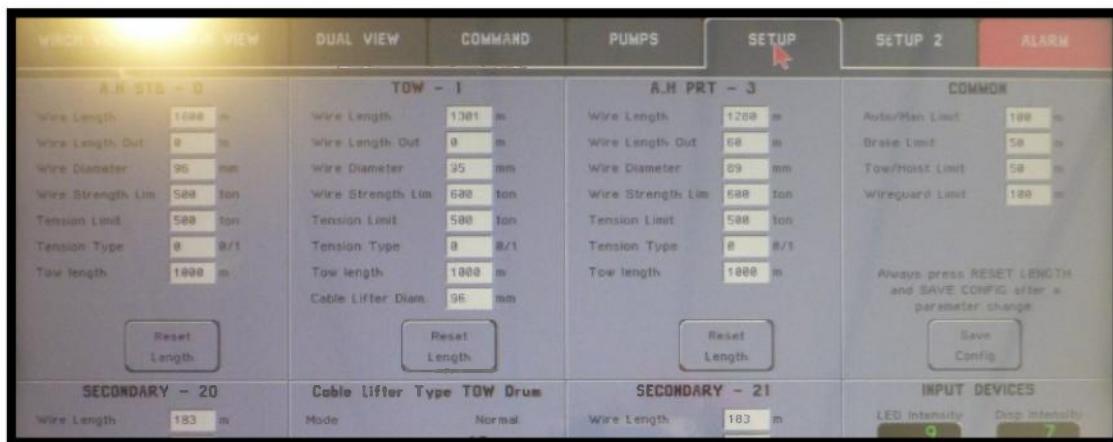
Figure 58: Photo of Towcon Setup screen showing “wire strength limit” for main towing drum is set at 600 tons. (USCG Photo)

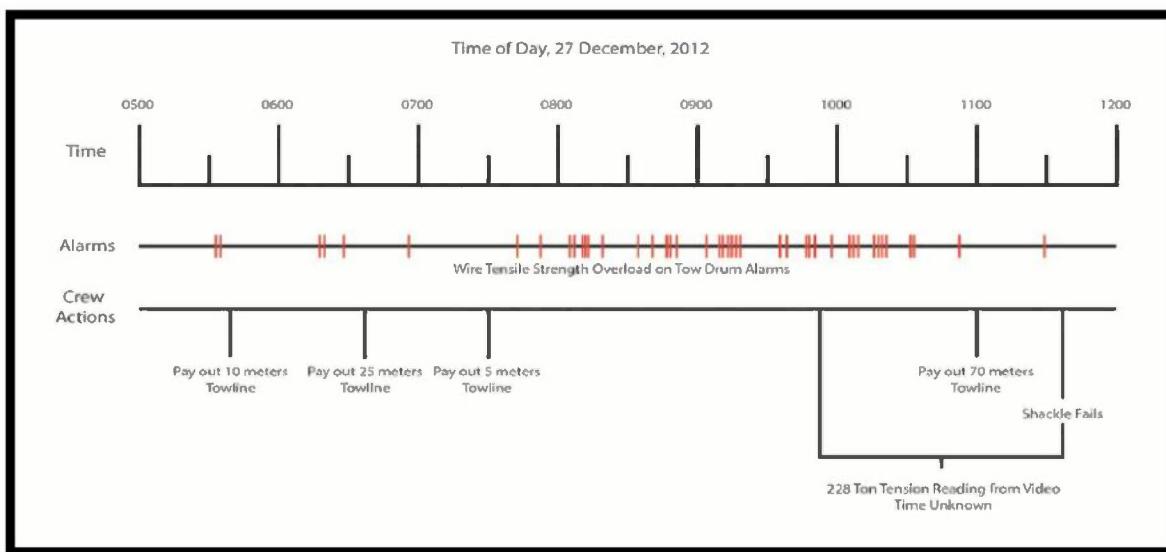
Figure 60: Summary of main towing drum data for the morning December 27, 2012 indicating time, alarms received towline length and shackle failure.¹⁰⁷ (USCG analysis)

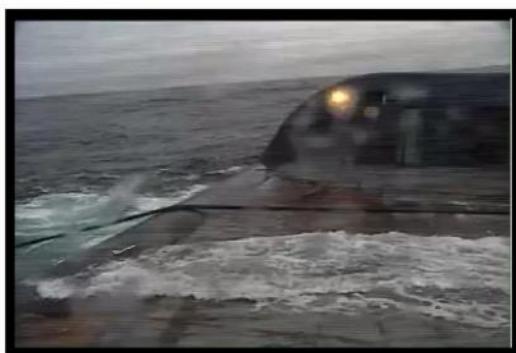
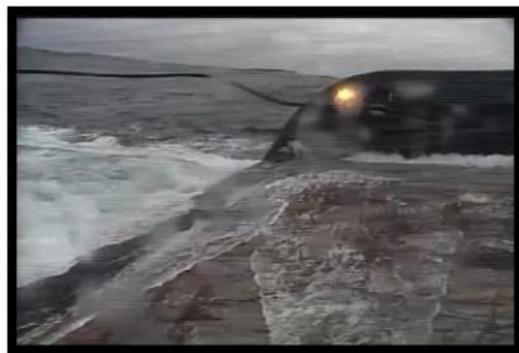
Figure 64: Starboard aft CCTV stills showing fluctuations in towline tension. Still on left shows lower tension at 11:32:06. Still on right shows high tension at 11:32:10 at the time of the shackle failure. (AIVIQ CCTV Provided by ECO)

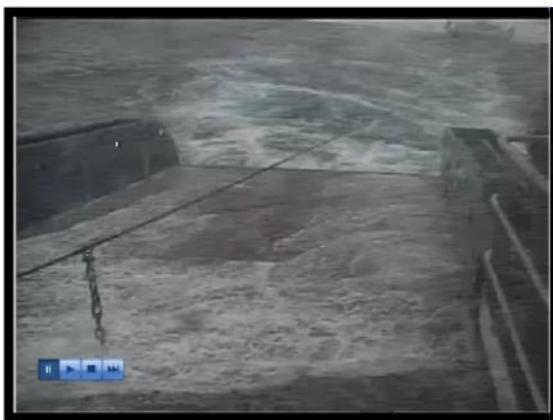
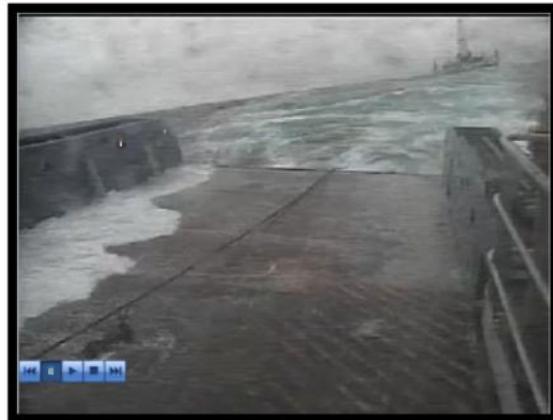
Figure 65: Port Forward CCTV stills showing fluctuations in towline tension. Still on left shows high tension at 10:54:48, demonstrated by the stiffness of the hogging chain (bottom right of still) and towline appearing to lead nearly horizontally toward KULLUK. Still on right shows low tension at 10:54:52, a mere 4 seconds later, with a slack Deadman chain and towline on the deck. (AIVIQ CCTV Provided by ECO)

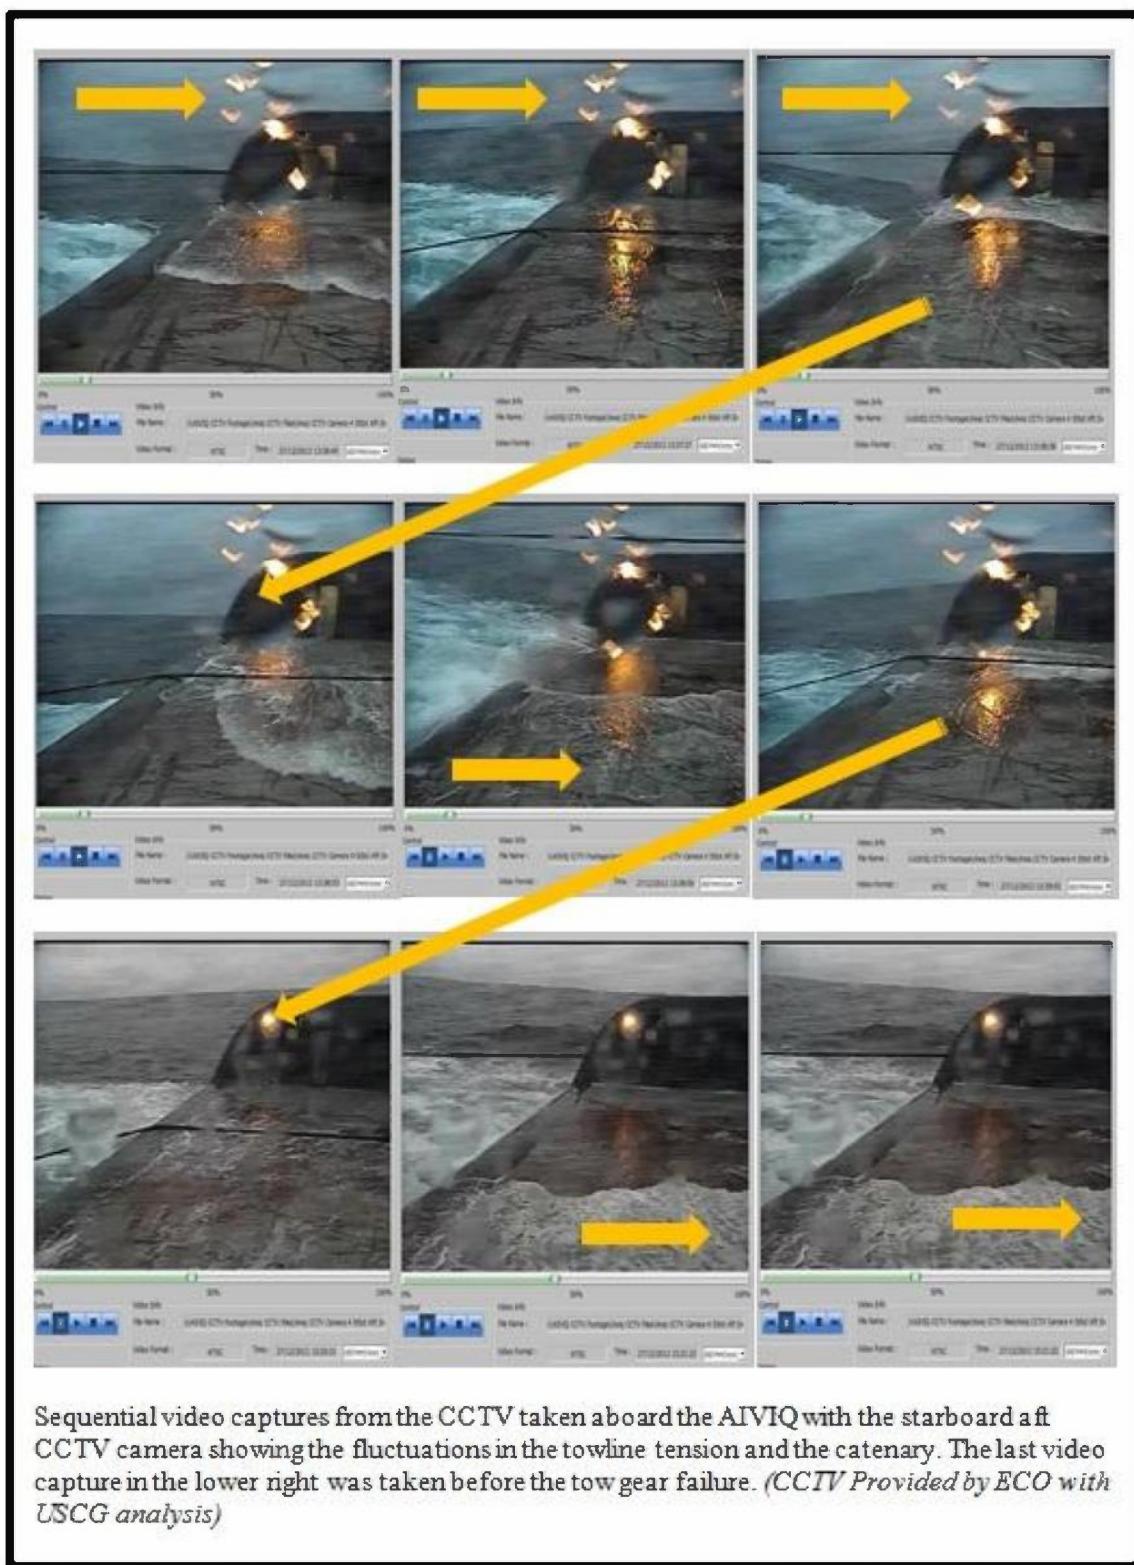
Sequential video captures from the CCTV taken aboard the AIVIQ with the starboard aft CCTV camera showing the fluctuations in the towline tension and the catenary. The last video capture in the lower right was taken before the tow gear failure. (CCTV Provided by ECO with USCG analysis)

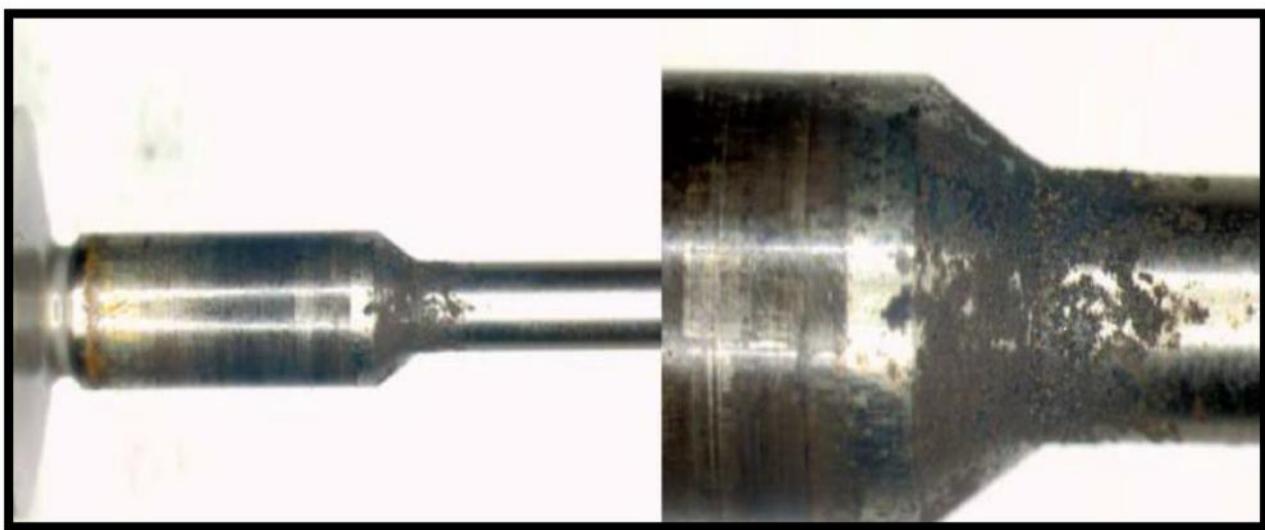
Figure 68: Two photos showing significant corrosion of injector check valve. (*Provided by Caterpillar*)

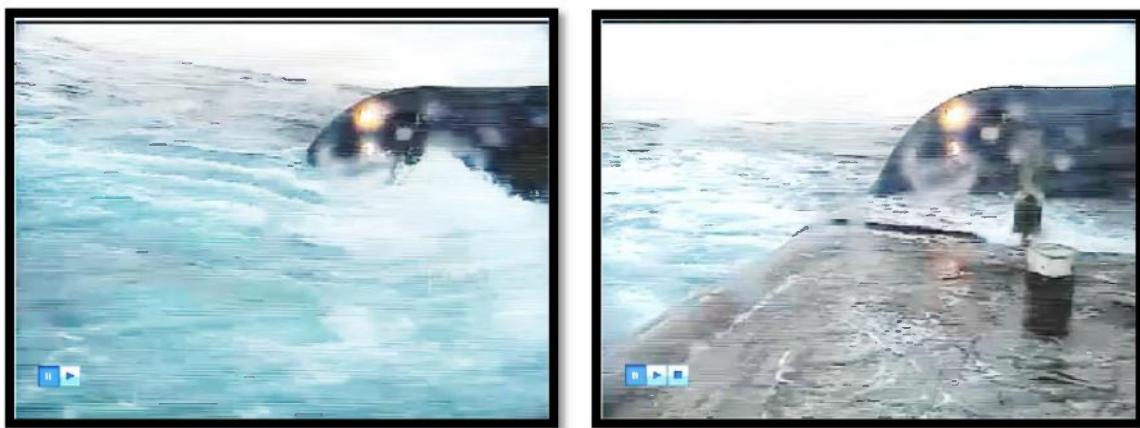
Figure 70: (left) Still from Starboard Stern CCTV showing seawater flowing over aft working deck and entering safety deck area at 15:16:47 on December 27. (right) Safety deck area at 15:16:55 after water clears from deck. Port side aft safety deck hatchway is visible. *(AIVIQ CCTV Provided by ECO)*

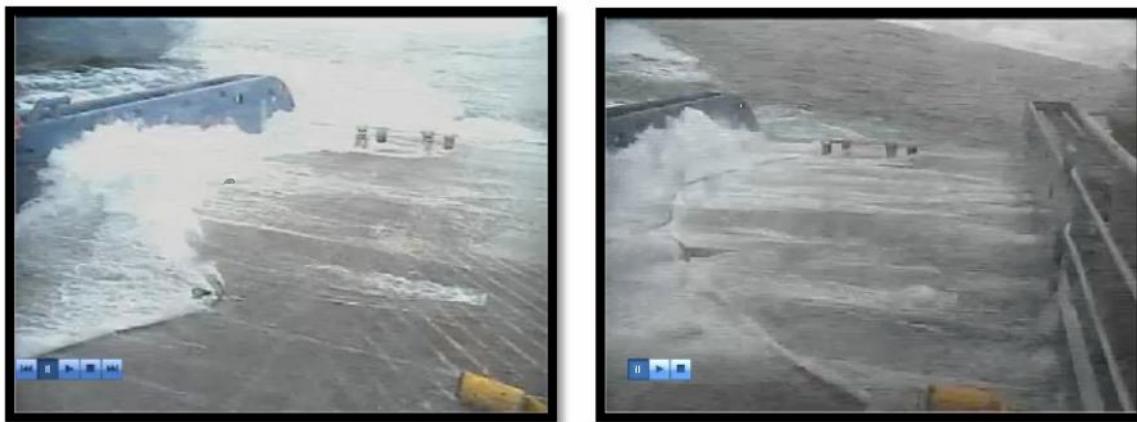
Figure 71: (left) Still from Port Forward CCTV showing seawater flowing over aft working deck and entering safety deck area at 14:39:09 on December 27. (right) Similar occurrence at 14:49:19 on December 27. (AIVIQ CCTV Provided by ECO)

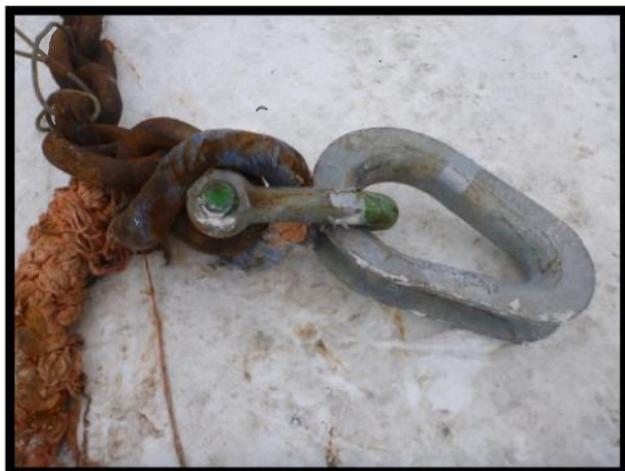
Figure 75: Photo of recovered emergency towline (eye on the KULLUK end of the emergency towline) showing missing thimble lashings allowing towline to separate from hard thimble. Blue Cordura® protection is also damaged. (USCG Photo)
