UNITED STATES COAST GUARD

**REPORT OF INVESTIGATION INTO THE
CIRCUMSTANCES SURROUNDING THE MULTIPLE
RELATED MARINE CASUALTIES AND
GROUNDING OF THE**

MODU KULLUK

ON DECEMBER 31, 2012

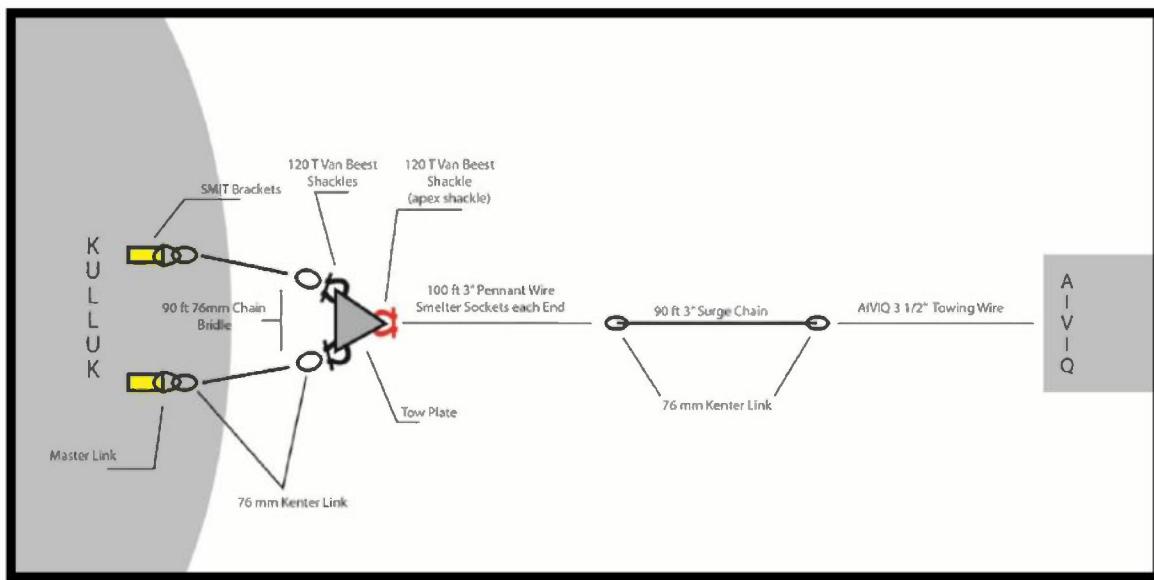
**Figure 11:** Diagram of towing configuration utilized in the KULLUK/ AIVIQ tows throughout 2012. (*USCG developed*)

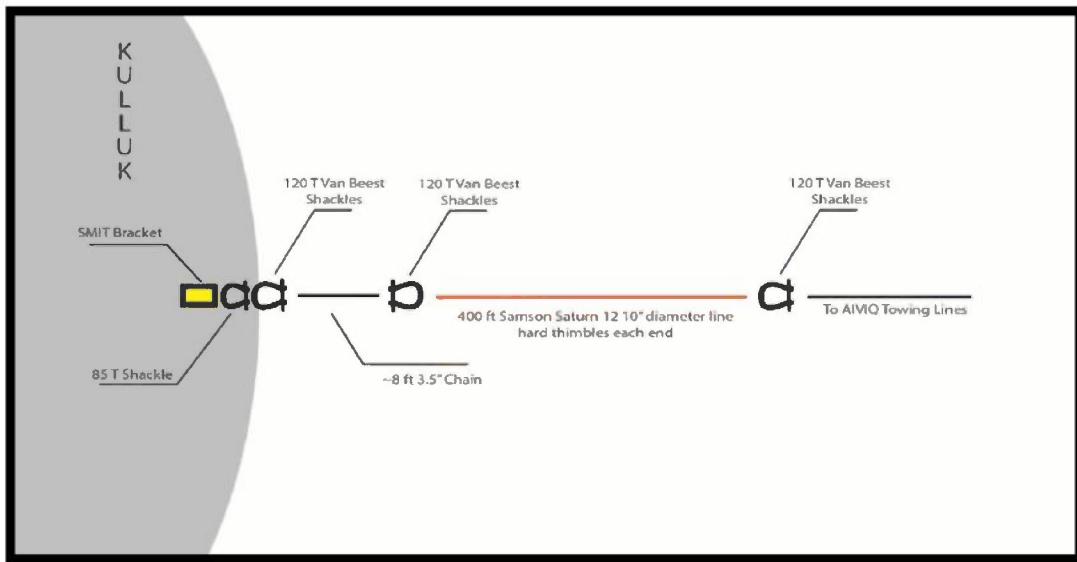
Figure 12: Diagram of Emergency Towline as designed for use when under tow. (*USCG developed*)

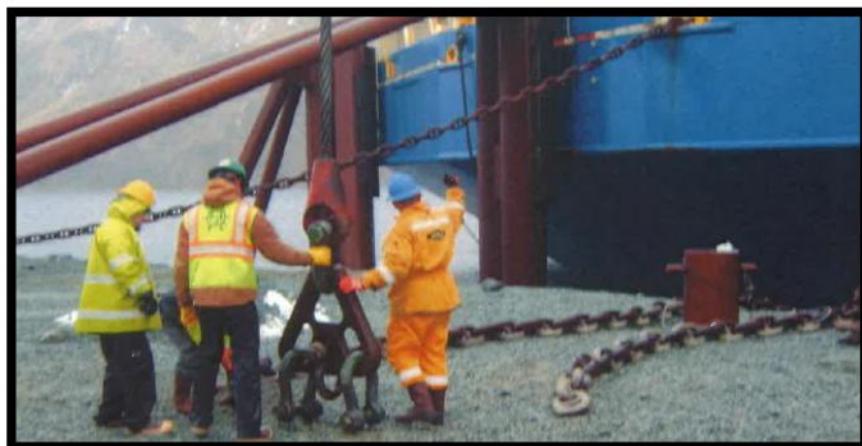
Figure 14: Preparing to Connect the Towing Plate to the Bridle Legs (*Photo courtesy of GL Noble Denton, Mr. [REDACTED]*)

61. The evidence indicates that the 120 ton apex shackle connecting the towing pennant to the towing plate had been in the same location for all previous KULLUK tows. The evidence also indicates that the rotation of shackles to even the wear and usage of these critical components was not part of the towing plan or equipment maintenance procedures.

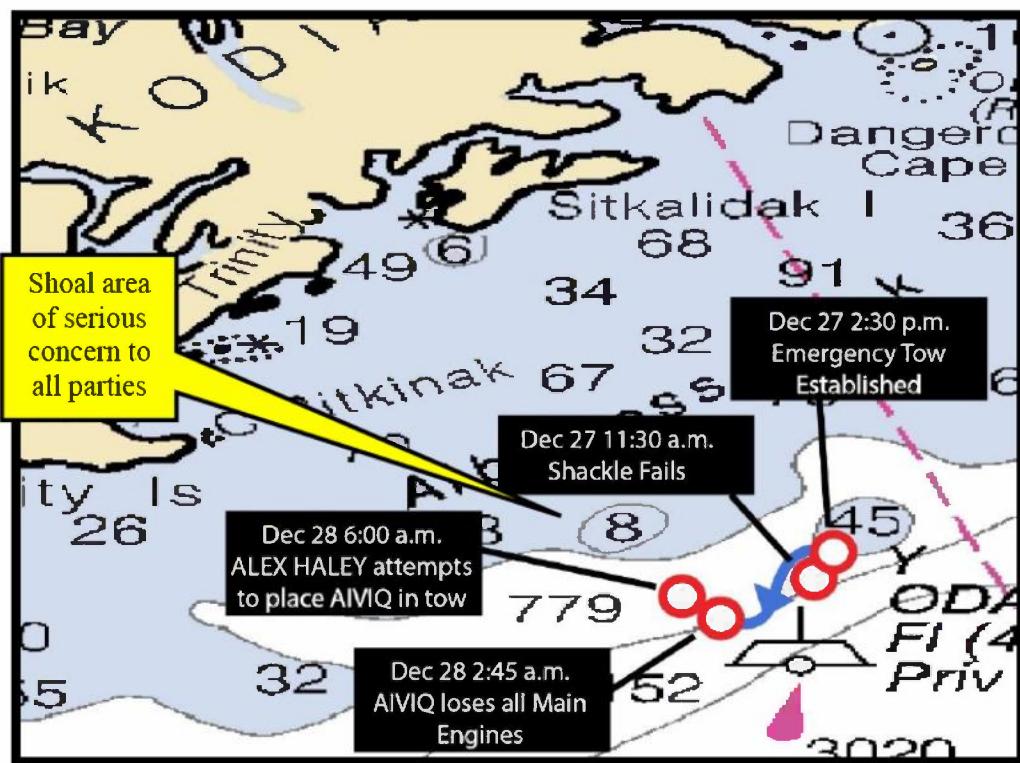
Figure 23: Diagram shows approximate locations of KULLUK between 11:30 a.m. December 27 and 6 a.m. December 28.⁶⁶ Significant events are highlighted and times are approximate. Blue line indicates general direction and location of KULLUK during this period. (*USCG analysis*)

96. Once the emergency tow was connected, the AIVIQ proceeded on a generally south-westerly course to keep increasing the distance away from Albatross Bank and an eight fathom shoal area (see Figure 23), which was north of their position. This shoal area was of serious concern due to the interaction of the sea and swell height and the 10.7 meter draft of the KULLUK.

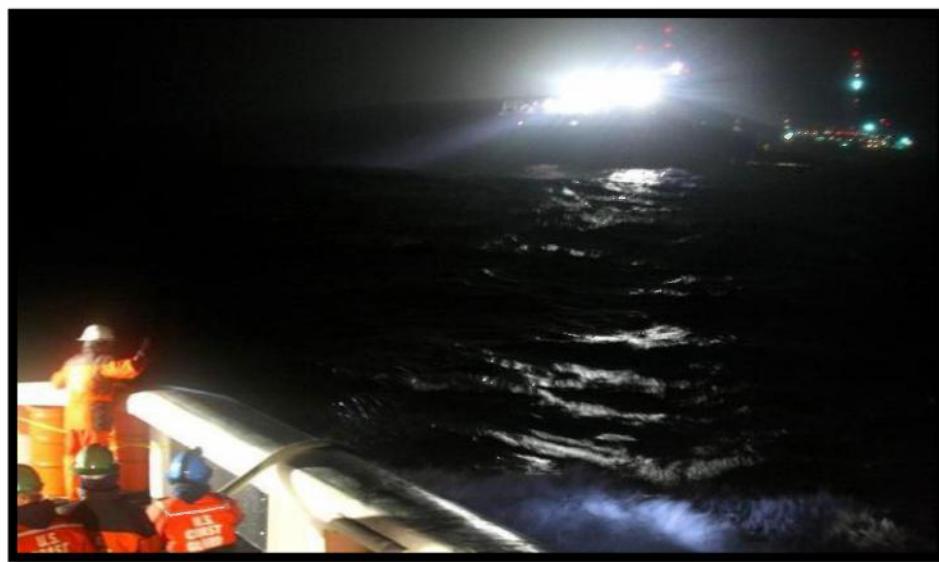
Figure 25: The crew of the USCGC Alex Haley attempt to pass the towline to the bow of the AIVIQ. Bright lights are located on the bow of the AIVIQ and the KULLUK is in the distance at the far right of the photograph. (USCG Photo)

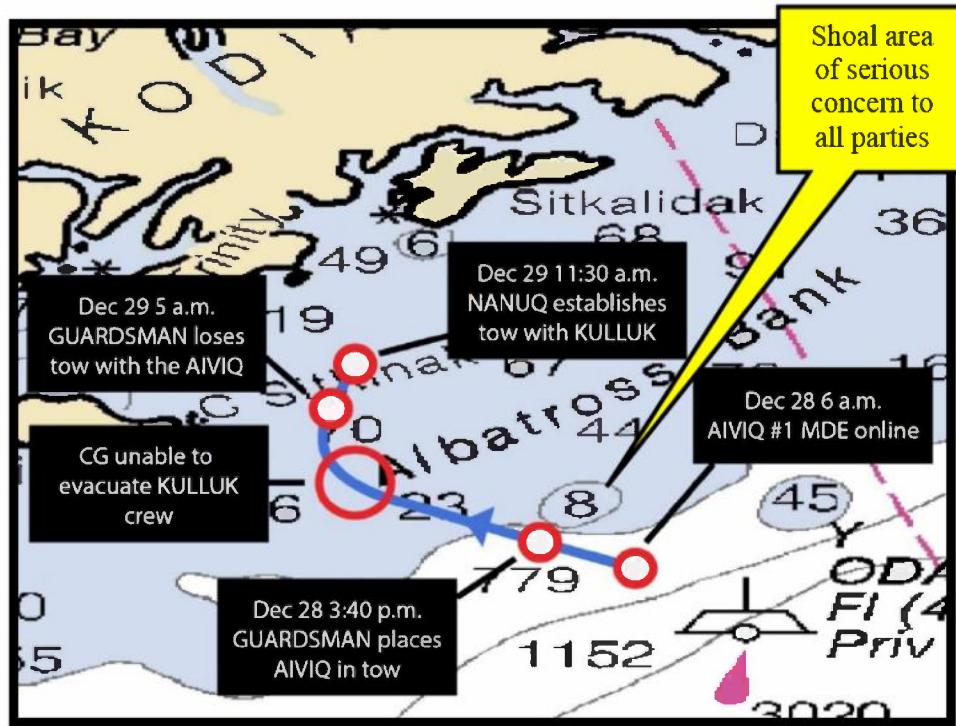
Figure 26: Diagram shows approximate locations of KULLUK between 0600 hrs December 28 and 1130 December 29. Significant events are highlighted. (USCG analysis)

113. With limited power on their #1 MDE and rotating azimuth and tunnel thrusters, the AIVIQ continued to be pulled astern by the KULLUK's wind driven drift, and the vessels were drifting slowly to the northwest. There was considerable concern that the KULLUK would drift on a marked 8 fathom area (see Figure 26), in which there was a chance that the KULLUK would ground or touch bottom in the seas. The drift of the KULLUK narrowly missed this area by approximately 8 miles, drifting to the west of this shallow bank.

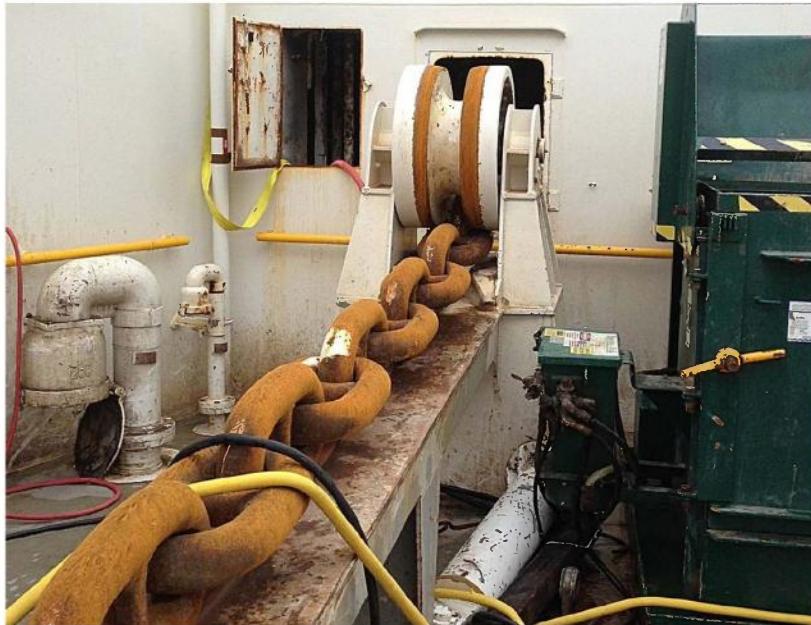
Figure 30: The anchor chain for the survival anchor leading out of the windlass room towards the hawsepipe. (Photo provided by Shell)

120. After the towing gear failure that occurred on December 27 the anchor was reported to have been dropped on two occasions. In one occasion this was as the result of a miscommunication between the KULLUK OIM and Tow Master and the crew of the KULLUK in a high stress situation. The anchor was released then quickly recovered. At this time the anchor was lowered to a reported depth of approximately two to three shots of chain or approximately 180 to 270 feet.

121. In the second occasion the OIM reported that the survival anchor was intentionally deployed to the bottom and was retrieved approximately six hours later. At this time the towing operation was near Albatross Bank a relatively shallower area of water 12-40 fathoms with a rocky bottom and areas of broken gravel. Nearer to the shore the water deepened with a mud bottom. According to the Van den Haak R study⁸² the LWT anchor is not ideal for coarse gravel or rocky bottom. When the anchor was retrieved the OIM reported that he believed the anchor was on the bottom and as evidence he said the last links of chain were "shiny" which he attributed to dragging on a rocky bottom. This statement is supported by HSE Technician [REDACTED] in his interview statement.

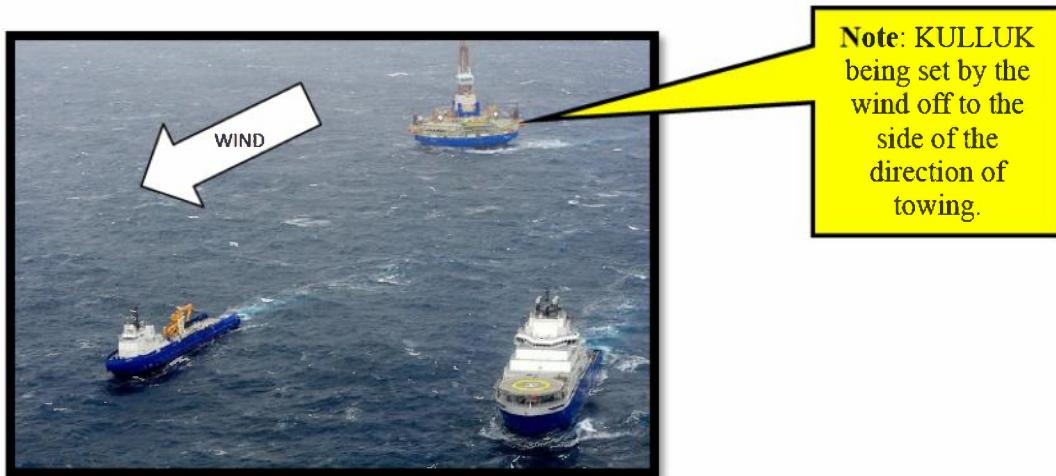
Figure 32: NANUQ on the left and AIVIQ on the right side of the photo with the KULLUK under tow in the distance (*USCG Photo*)

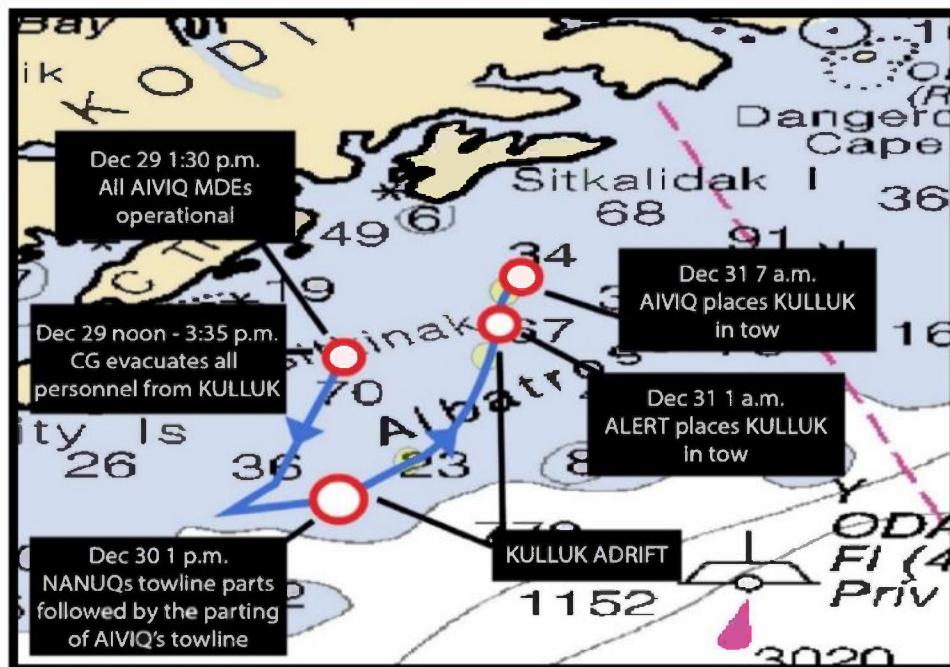
Figure 33: Diagram shows approximate locations of KULLUK between 1200 hrs December 29 and 0700 hrs December 30. The blue line indicated general direction and location of KULLUK during this period. (*USCG analysis*)

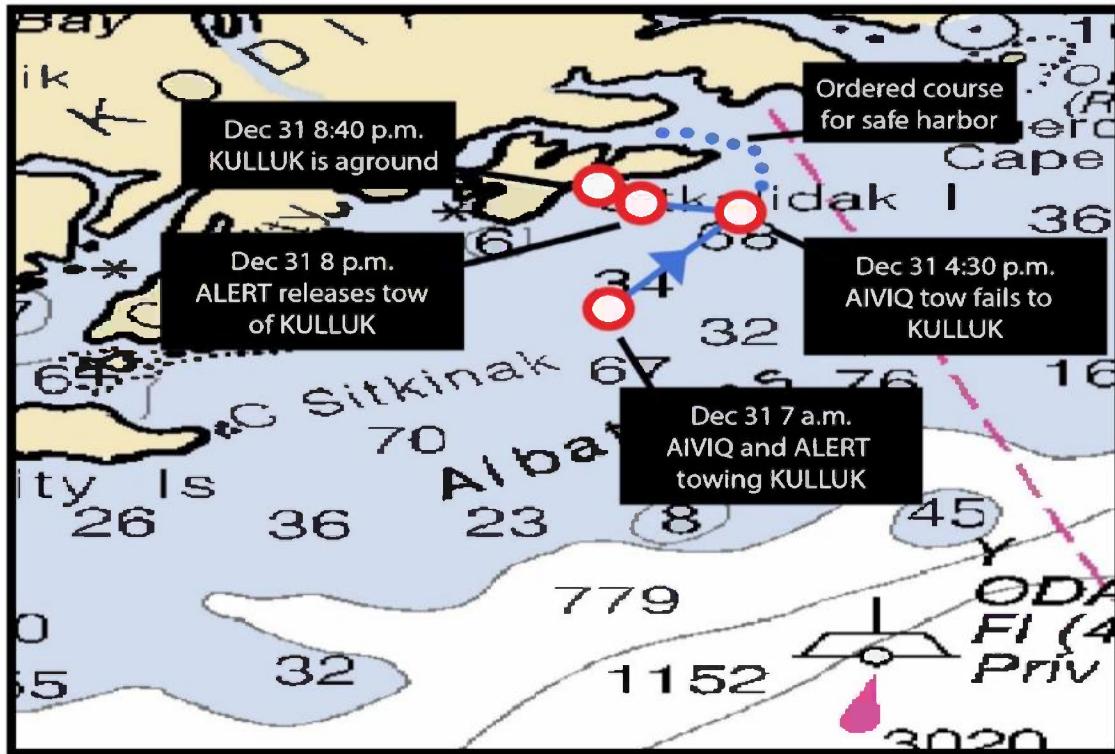
Figure 37: Diagram shows approximate locations of KULLUK between 0700 hrs AKST December 31 up to the grounding of the KULLUK. Significant events are highlighted. (USCG analysis)

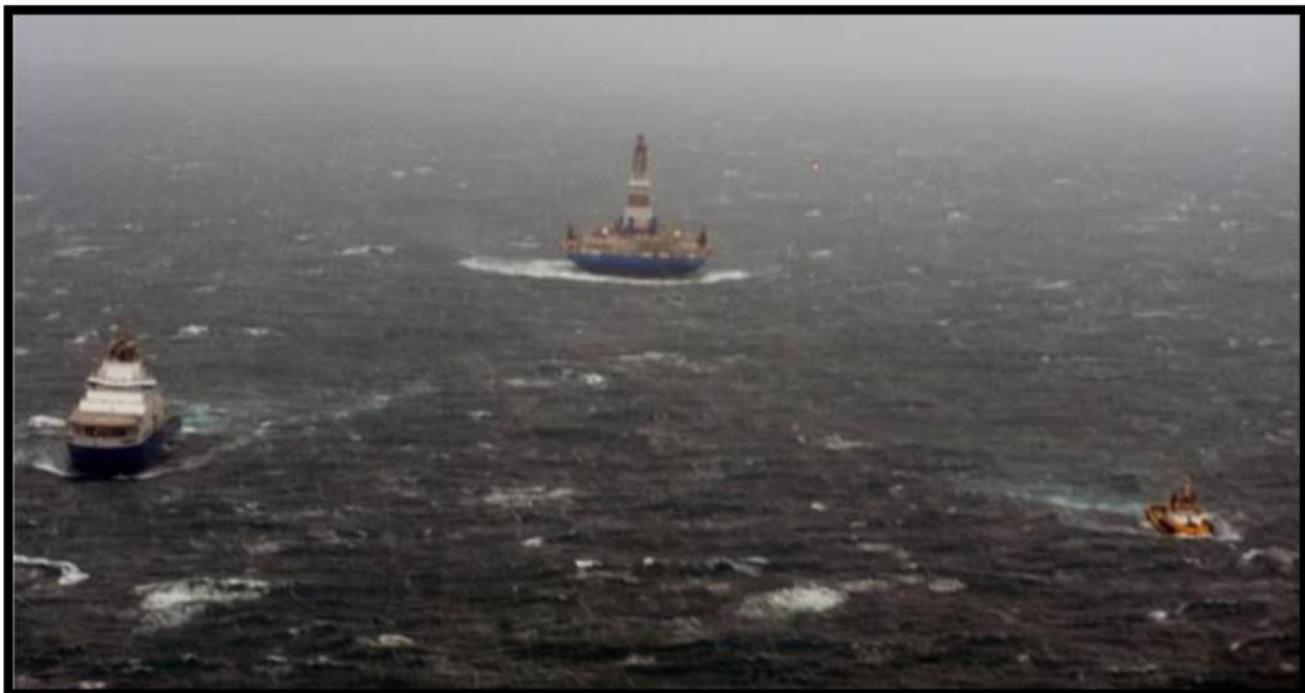
Figure 38: KULLUK under tow with the AIVIQ (left foreground) and the ALERT (right foreground) on December 31. (*USCG Photo*)

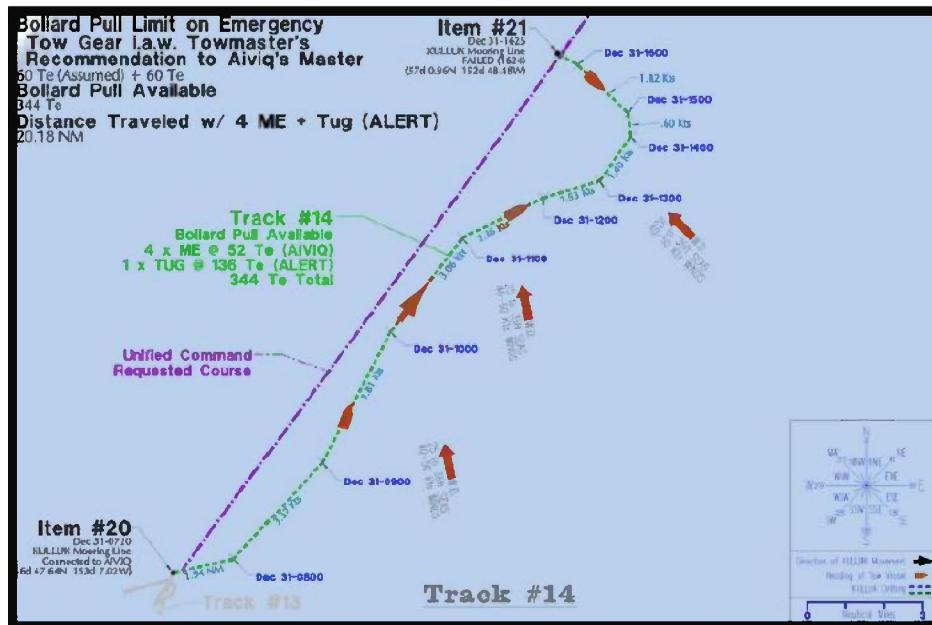
Figure 42: Position of the vessels. The purple dashed line represents the course ordered by the Unified Command. (*Chartlet provided by ECO for the Declaration on AIVIQ Bollard Pull, DECLARATION OF [REDACTED] WITH RESPECT TO THE GROUNDING OF THE DRILL RIG KULLUK, presented without editing*)

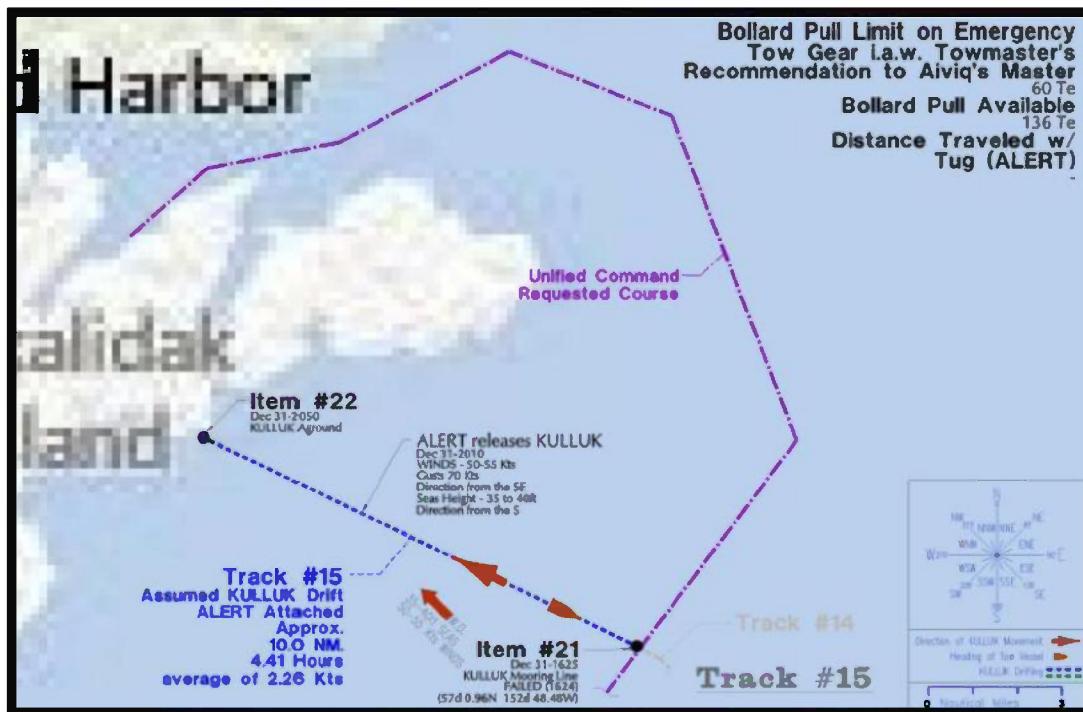
154. At approximately 1630 December 31, the AIVIQ's tow pennant failed and the ALERT became the single vessel towing the KULLUK. The AIVIQ's 3 inch 100 foot pennant wire, the same wire that was part of the original towing configuration had parted. The ALERT was now towing the KULLUK alone in extreme weather conditions.

Figure 43: Position of the vessels. The purple dashed line represents the course ordered by the Unified Command. (*Chartlet provided by ECO for the Declaration on AIVIQ Bollard Pull, DECLARATION OF [REDACTED] WITH RESPECTTO THE GROUNDING OF THE DRILL RIG KULLUK, presented without editing*)

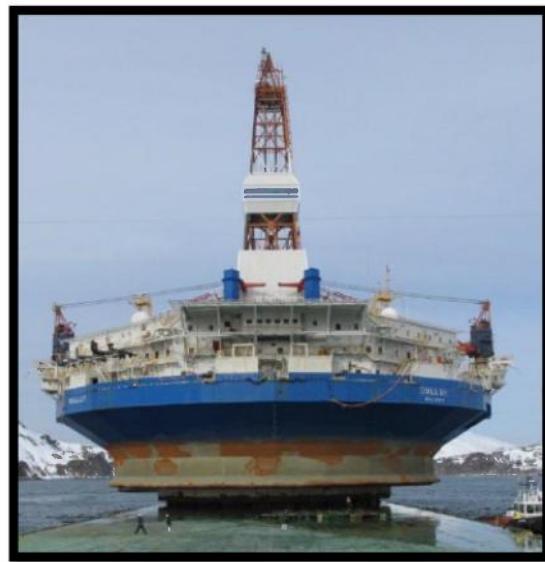
3. The KULLUK's hull is conical in design, with no distinctive bow or stern. The design of the vessel exposes a broad expanse of the hull to hydrodynamic effects of the sea, including the effects of current and swells/ wind driven seas. The derrick, cranes, accommodation and control spaces result in significant sail area or the effects of wind on the vessel. The severe outward slope of the hull below the chine increases overall hull resistance to the seas when the vessel is pitching, rolling or heaving in heavier weather.

Figure 46: The KULLUK out of the water and loaded on the deck of a heavy lift ship. (USCG photo)

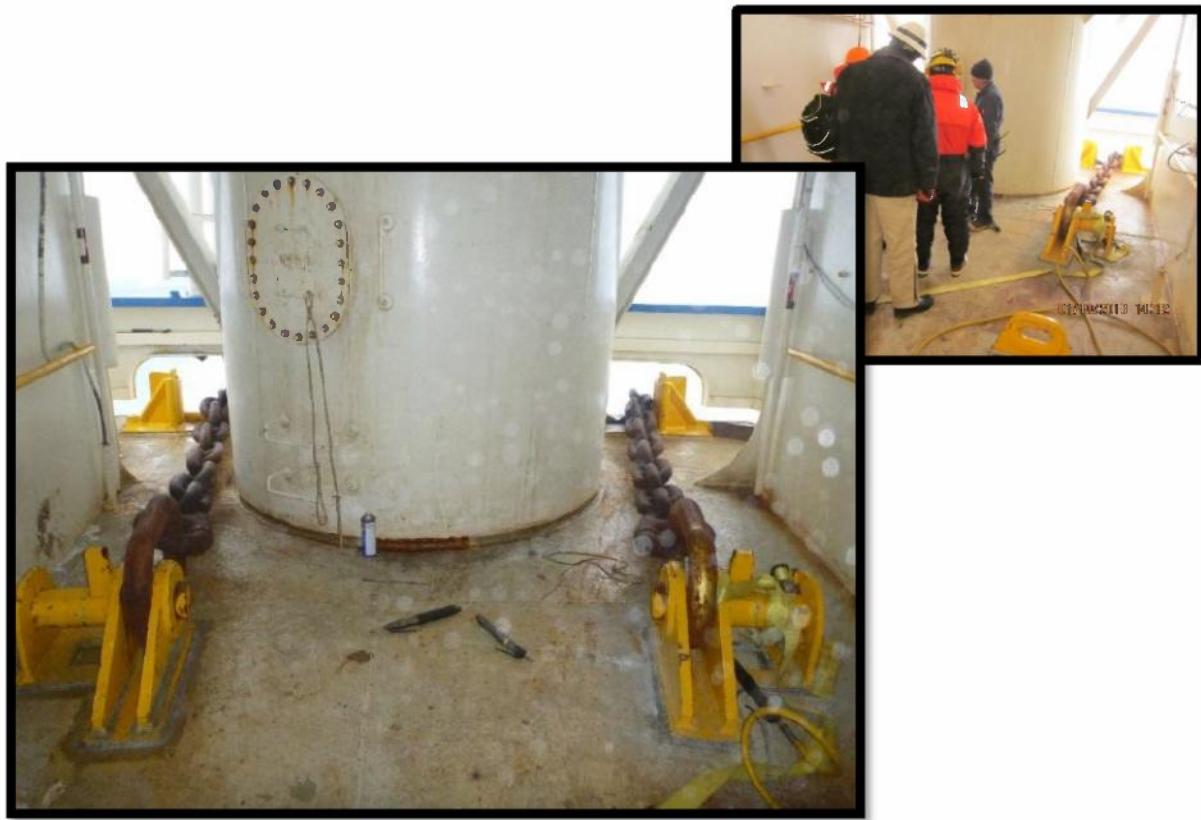
Figure 49: Photo of towing bridle connections to Smit Brackets (*USCG Photo*)

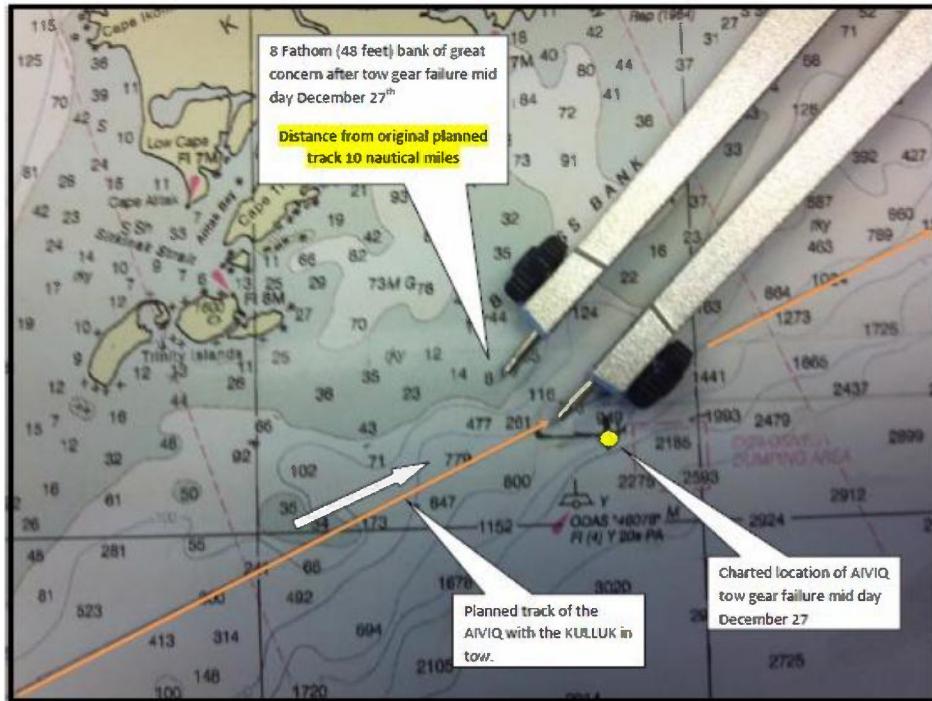
25. In hindsight, this route's proximity to shoal water and land masses proved to be a critical factor in the towing and response operations. At the time of the shackle failure, the KULLUK was approximately 40 miles from the closest point of the islands of Kodiak Island and less than 10 miles from Albatross Bank. The loss of the AIVIQ's engines and extreme weather moved the KULLUK north toward these hazards. This planned route denied the proper sea room necessary should a towline fail or the towing vessel experience a mechanical breakdown, particularly with no assistance or additional towing vessels onsite. Additionally, should the tow need to heave to in the event of a weather event, there was little safe water available to ride out storms.

Figure 50: Chart showing planned track line for towing of KULLUK demonstrating close approaches to land and other hazards. (*USCG Developed*)

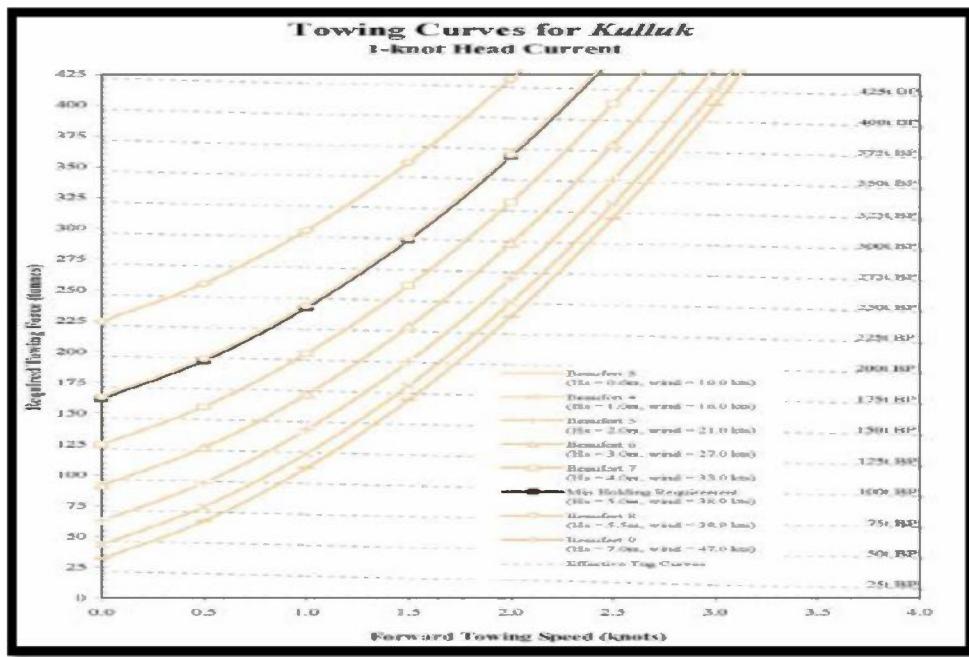
31. The 2010 study contains towing resistance curves for Beaufort 3 through 9 weather conditions. The 10% exceedance level for the December 2012 tow indicates 9.2 meter seas and 44.6 knot winds. These weather conditions are similar to Beaufort 9 storm conditions, being 2.2 meters above Beaufort 9 seas and 2.4 knots below Beaufort 9 winds. Referencing figure 52, extracted from the study, the bollard pull necessary to maintain position in a 1 knot current would require 225 tons of effective bollard pull by the towing vessel. Referencing the same document, a 200 ton effective bollard pull would be necessary under the same circumstances with no current. It should be noted that the prevailing currents along the southern coast of Alaska are out of the east, meaning that the KULLUK would most likely be towed into the current.

32. After analyzing the data, the AIVIQ would be capable of generally maintaining position with the KULLUK in tow during Beaufort 8 weather in 5 meter seas and 40 knot winds while encountering a 1 knot current, with all forces acting against the tow into the wind and seas. In weather conditions in excess of this standard, as predicted by the Metocean study, the AIVIQ could not be expected to maintain position, and would be pulled astern by the forces acting on the KULLUK. In the Alaskan maritime environment towing operations that are experiencing poor weather do at times allow themselves to be pulled astern until the weather subsides. These tow planners build sea room into the planning to allow for the weather. In the case of the KULLUK towing operation for December 2012, this would be an unacceptable risk considering the length of tow, the near shore routing, and the fact that, as the Metocean data suggests, this weather may occur over 10% of the tow transit.

Figure 52: Towing Curves (Tow Resistance) for the KULLUK with 1 knot head current as provided by Global Maritime 7/6/10 (*Provided by Shell, Shell Alaska "Bollard pull calculations for Towing KULLUK from McKinley Bay to OSI South Reef Dock, Captains Bay, Unalaska Island, Aleutian Islands" GMH-6565-2575*)

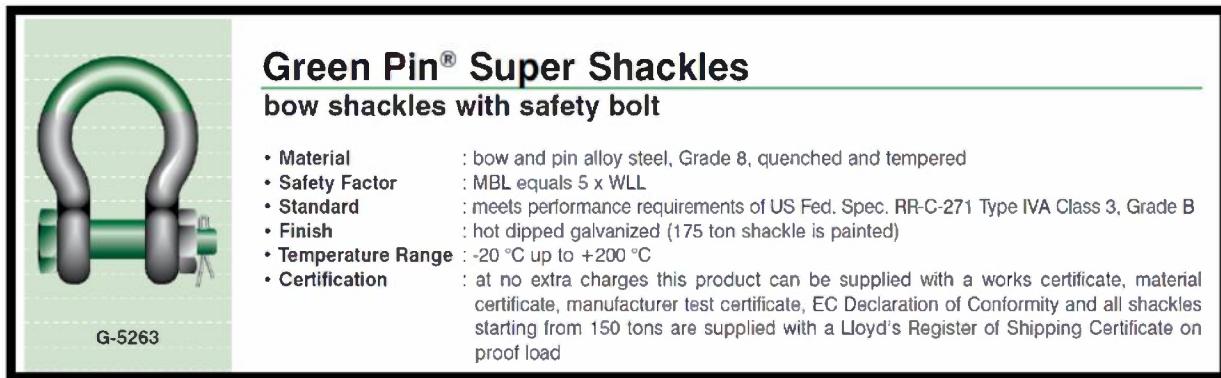
Figure 54: Description of Van Beest Green Pin Super Shackles from the manufacturer's catalog. (*Van Beest product catalog available on the internet*)

38. The apex shackle that failed at approximately 1135 on December 27 has been identified as a Van Beest Green Pin Super Shackle.⁹⁵ It was one of six that were incorporated into the tow to replace the 85 ton shackles originally intended. As all the remaining 5 shackles were from the same "YP" manufacturing batch, it is assumed that the missing shackle is of that batch as well. During the investigation, Shell provided documentation that suggests that these "YP" batch shackles were purchased from Van Beest in 2007.⁹⁶ The work and usage history of the shackles could not be definitively ascertained, other than they were incorporated as part of the KULLUK towing configuration since July of 2012. Testimony suggests that these shackles may not have seen usage prior to this time.

41. The Proof Load (PL) of this shackle is listed by the manufacturer as 240 tons, or twice the WLL. The U.S. Navy Towing Manual defines the Proof Load of shackles as “the load at which no permanent deformation is observed after the load is released.” Shackles are often tested to their Proof Load prior to distribution by the manufacturer, and Van Beest conducts such tests for all Super Shackles batches prior to sale.

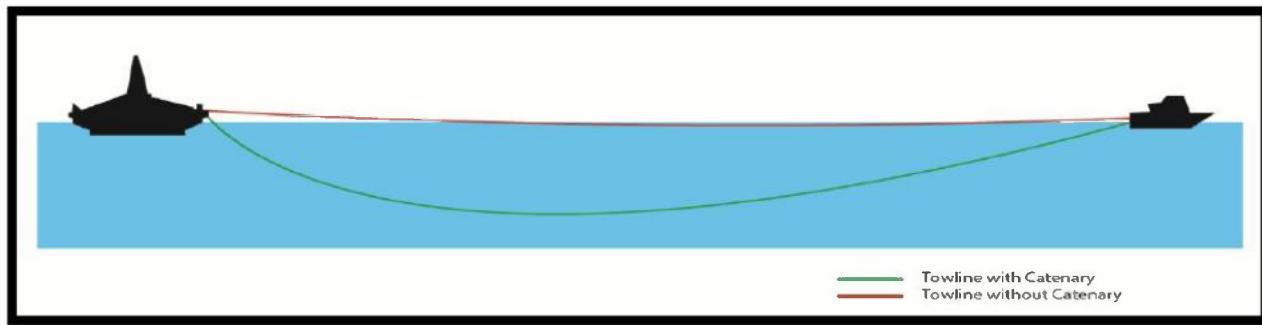
Figure 56: Diagram illustrating the use of catenary in a towing system (*USCG Developed*)

towing vessel causes the catenary to decrease in depth and the tension on the towline to increase. If the vessels increase the distance between each other and the length of the towline is increased the catenary is maintained and the shock load continues to be reduced. As such, a deep catenary generally results in a lower average tension, allowing the towline to rise and fall to accommodate vessel ship motions.⁹⁹ In practical terms, the catenary acts as a type of spring that absorbs fluctuations in towline tension. It acts to compensate between the relative motions of tow and towing vessel.

50. According to the *Navy Towing Manual*, catenary may not be as effective as previously assumed in towing operations to reduce extreme tensions. “It has been suggested that, for the motion frequencies found in most towing situations, the wire towline does not have time to fully resume its former deep catenary when the tension eases before the next surge in tension occurs. The net result over time is that the wire catenary remains flat, thereby providing somewhat less spring than previously thought. Following this line of thought, more of the spring remaining in the system must be attributed to the elastic stretching of the wire itself.” This serves as a warning that should the motions between the two vessels be frequent, that catenary may not provide an effective means for reducing extreme loads on the towline. Evaluation of the AIVIQ’s CCTV footage demonstrates that, at times, the tensioning cycles are frequent, in periods of 8 – 15 seconds, some in as little as 4 – 6 seconds, indicating that the desired catenary effects would be diminished.

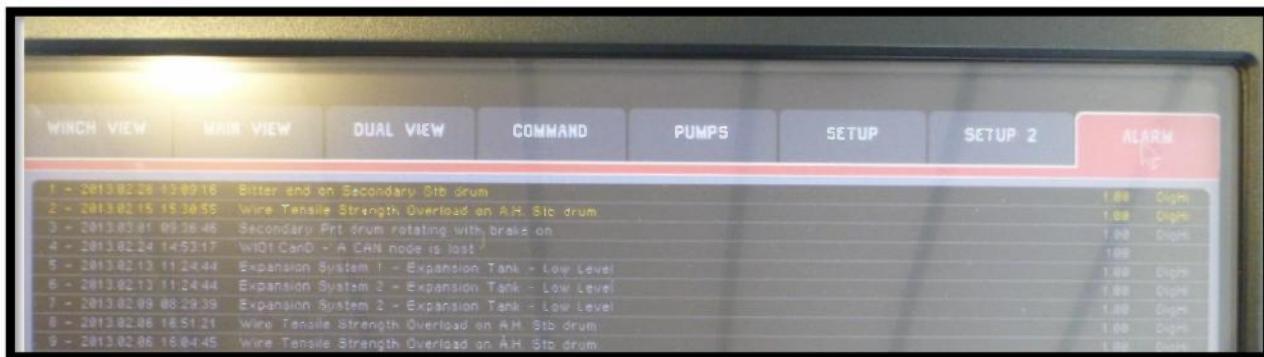
Figure 59: Towcon alarm screen indicating alarms received on the bridge monitor, requiring acknowledgement of the bridge officers. Alarms indicated are for a later time period than investigation scope. (USCG Photo)

69. The AIVIQ's towing winch system contained an advanced computerized monitoring and control system manufactured by Rolls-Royce called the Towcon RT. This system contained a means to monitor strain/tension of the towline (in Tons), tow line length, hydraulic pressure, among others, and would alarm should any of the pre-set limits be exceeded. With respect to tension monitoring, the user could easily set any strain/ tension limit by which an alarm would be activated. No user set tension settings were established, and the only high tension alarm active was a manufacturer set alarm that would activate upon reaching 50% of the tensile strength of the main tow drum. The tensile strength was set prior to the voyage at 600 tons, indicating that the alarm would activate at 300 tons of tension. See Figure 58.

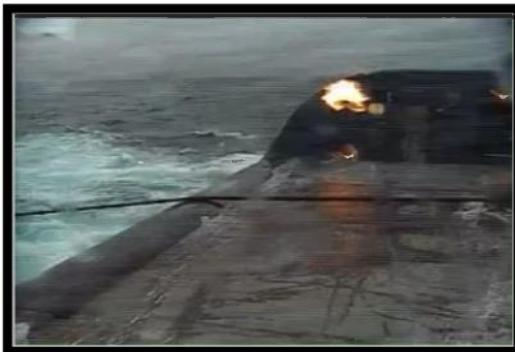
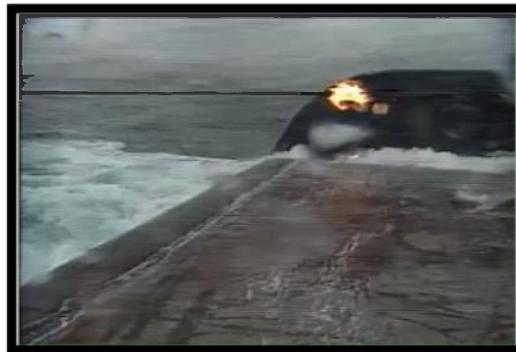
Figure 61: Starboard aft CCTV stills showing fluctuations in towline tension. Still on left shows lower tension at 10:12:42. Still on right shows high tension at 10:12:48. (*AIVIQ CCTV Provided by ECO*)

tow wire goes taut and comes off the roller and is suspended into the air above the deck. Higher tensions are also indicated by a loss of catenary between the towing vessel and tow.

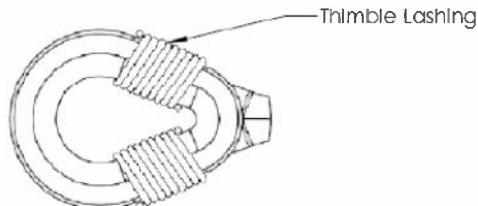
Figure 74: Diagram of the end of the emergency towline with Codura® abrasion protection and metal thimble lashed into place (*Courtesy of the Sampson Rope Technologies, Inc.*)

118. The failure of the apex shackle was discussed previously in the analysis. The emergency towline was a capable 400 foot line, possessing a breaking strength of over 400 tons. Testimony indicates that the AIVIQ attempted to maintain a lower tension on the line during the course of the tow, and Towcon data retrieved for the time period indicate that the tension never reached 300 tons during usage of the line. The failure occurred at the AIVIQ side of the towline at the eye end of the emergency towline. Codura® chaff protection was provided in the area of the eyes in the end of the towline consisting of the abrasion resistant material around the line itself and a steel thimble held in place with lashings as detailed in the illustration below.

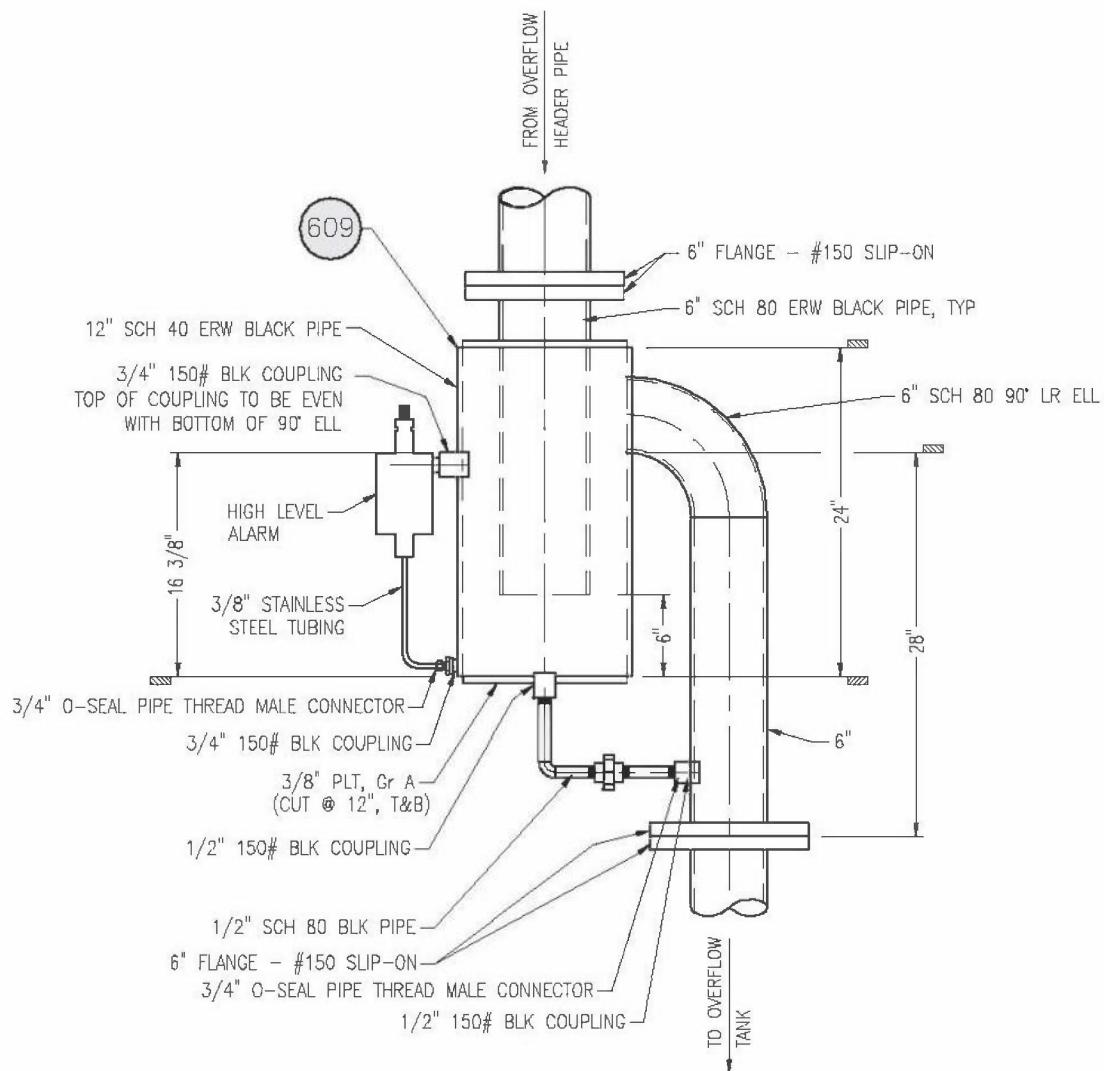
Figure 1 - Fuel Oil Overflow Alarm Sensor Arrangement (Source: reference (q))

- ii. Reference (q) shows an overflow alarm sensor arrangement (see Figure 1). The 8-inch vent/overflow headers are each reduced to 6-inch pipe prior to reaching the overflow alarm sensor arrangement. Per references (e) and (f), the crew experienced many problems with the fuel oil vent/overflow alarm system prior to the casualty.

- 8/06/2012: Reference (f) 0900 - Empty both Port and Stbd Overflow Alarm Pots on the F/O Alarm Piping. Both drains were clogged. Breaker #17 in EP-201 is Back Online.

- 08/25/2012: Reference (f) - Overflow alarm activated, found drain lines clogged on port side. Removed and cleaned.
 - 09/04/2012: Reference (e) - Cleaned P/S Overflow Collection Pipe Drains.
 - 11/21/2012: Reference (e) - Drained port overflow alarm system.
 - 12/26/2012: Reference (f) - Secured fuel overflow breaker ELP-201 Bkr 17.
- iii. In reference (c), the Chief Engineer acknowledged that the water on deck shown in a photograph during the interview was well above the height of the vent/overflow tank vents.

- iv. Reference (f) shows the circuit breaker for the fuel oil vent/overflow alarm was opened during the Midnight to Noon watch on 12/26/2012. In reference (c), the Chief Engineer indicated that during rough seas, with a full load of fuel, a certain amount of fuel would overflow into the FO Overflow Tank. If seawater entered the vent and overflow system, it would cause an overflow alarm condition.

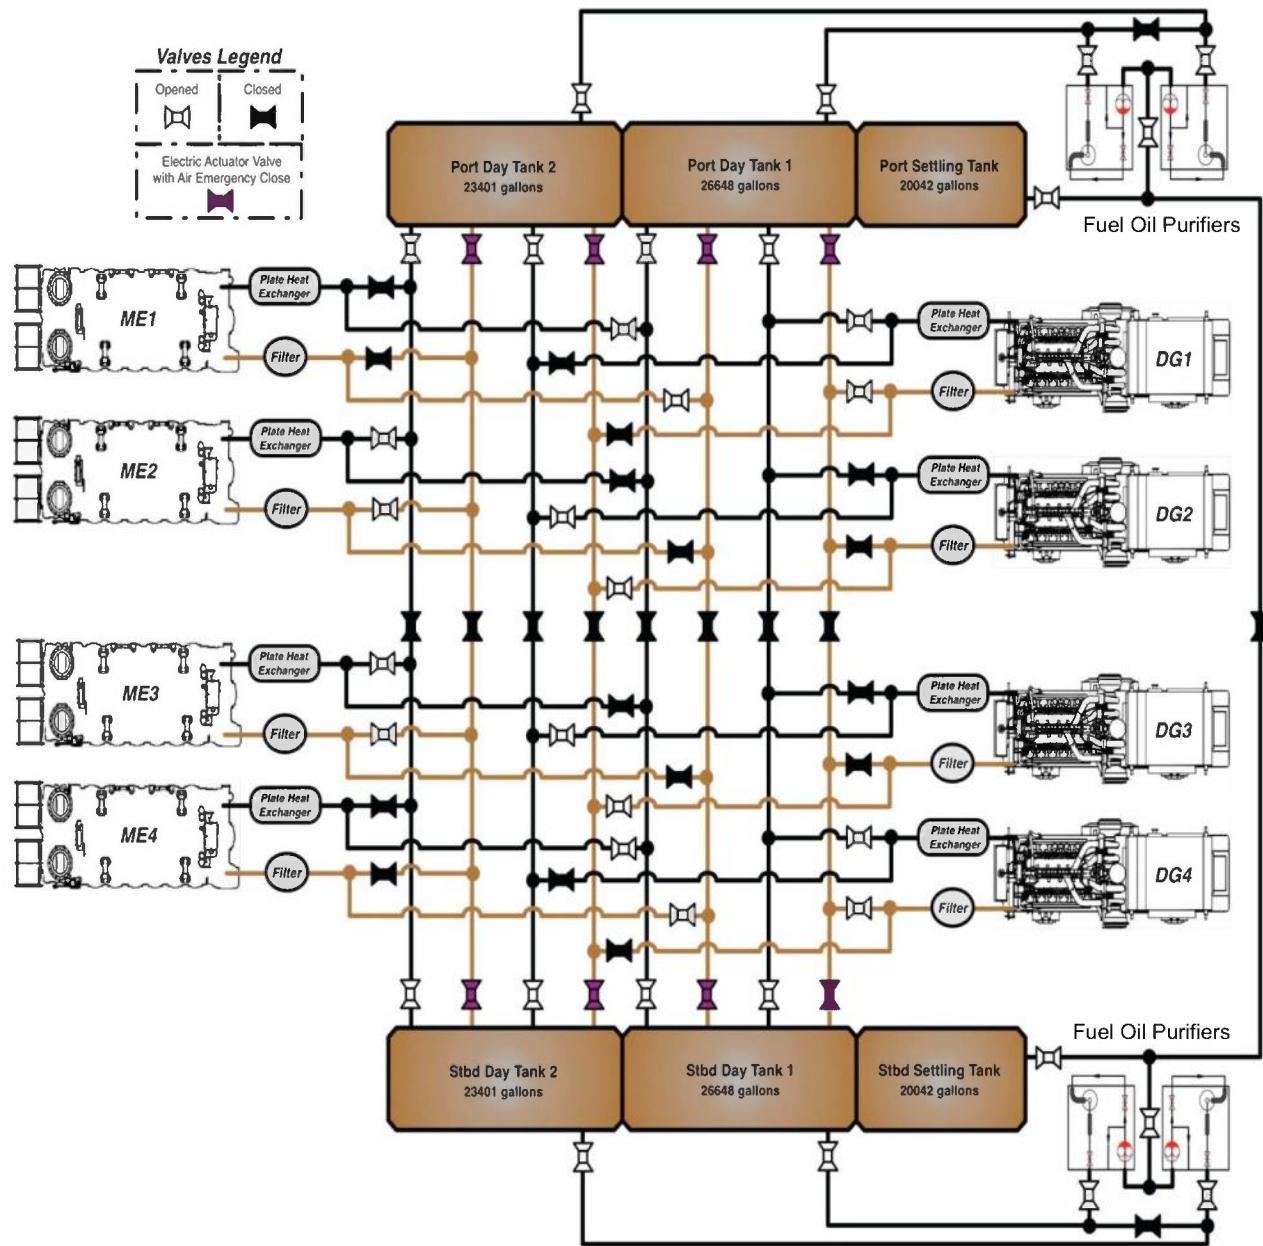
Figure 2 - AIVIQ FO Service System Diagram (Source: reference (s))

- i. Four fuel oil purifiers are installed, two port and two starboard (see Figure 2). One electric fuel oil heater is provided for each purifier pair. Fuel would be purified during transfer from the settling tanks to the day tanks. We note that the fuel oil system aboard AIVIQ lacks the ability to purify fuel oil in any of the day tanks via recirculation. While this is not required by reference (v), it is encouraged by the engine manufacturer in Figure 9 of reference (z), which shows a typical purifier installation and includes provisions for recirculating fuel oil in the day tank. It appears that the only means on board AIVIQ to purify oil in a day tank is to fill it until the fluid level reaches the overflow piping. Reference (g) shows overflow piping installed 3-inches from the top of each of the day tanks. These

- (b) Per references (r) and (s), the fuel oil service system is to be split at all times between the four fuel oil day tanks, with one main engine and one ship service diesel generator supplied by each day tank (see Figure 2). If operated in accordance with the references (r) and (s), the Worst Case Failure for the fuel oil service system (which is identified as day tank fuel oil contamination), would be limited to the loss of one main engine and one ship service diesel generator (notwithstanding cross contamination of day tanks via the fuel oil tank vent and overflow system discussed earlier).
